# Manhole Inspection Summary

Manhole # S21WW1031MH

Insp Date: **11/29/06 1:29 PM**

**Location** Address: **4 HAMLET HILL CT**

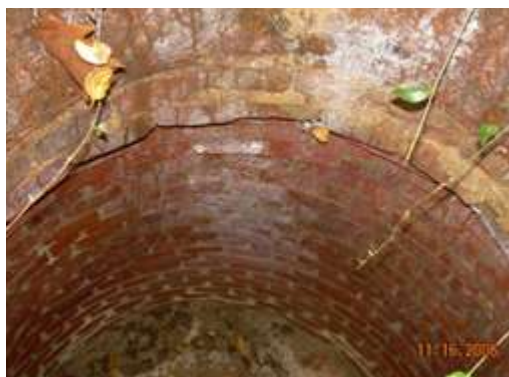
Defect

Infiltration: ☐ None ☒ **Joint** ☐ Cracks ☒ **Mortar** ☐ Roots ☐ Wall

Adjustment infiltration.

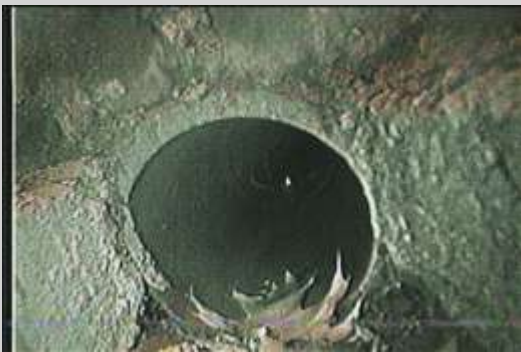
### 6 in. Circular Gravity Sewer Pipe Out @ 12 O'Clock

Pipe Material: **Clay** ☐ Pipe Lined

Invert Depth: **6.62** (ft.) Flow Characteristics: **Fast**

Deposits: ☒ None ☐ Mud ☐ Sludge ☐ Debris ☐ Grease

Infiltration: **None** Pipe Seal Cond: **Unknown**

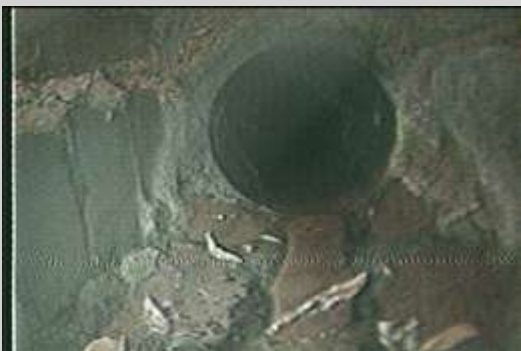
### 6 in. Circular Gravity Sewer Pipe In @ 4 O'Clock

Pipe Material: **Clay** ☐ Pipe Lined

Invert Depth: **6.45** (ft.) Flow Characteristics: **Fast**

Deposits: ☒ None ☐ Mud ☐ Sludge ☐ Debris ☐ Grease

Infiltration: **Evidence** Pipe Seal Cond: **Cracked**
